1994 Northridge Earthquake

Performance of Structures, Lifelines and Fire Protection Systems

NISTIR 5396

March 1994
Building and Fire Research Laboratory
National Institute of Standards and Technology
Gaithersburg, MD 20899

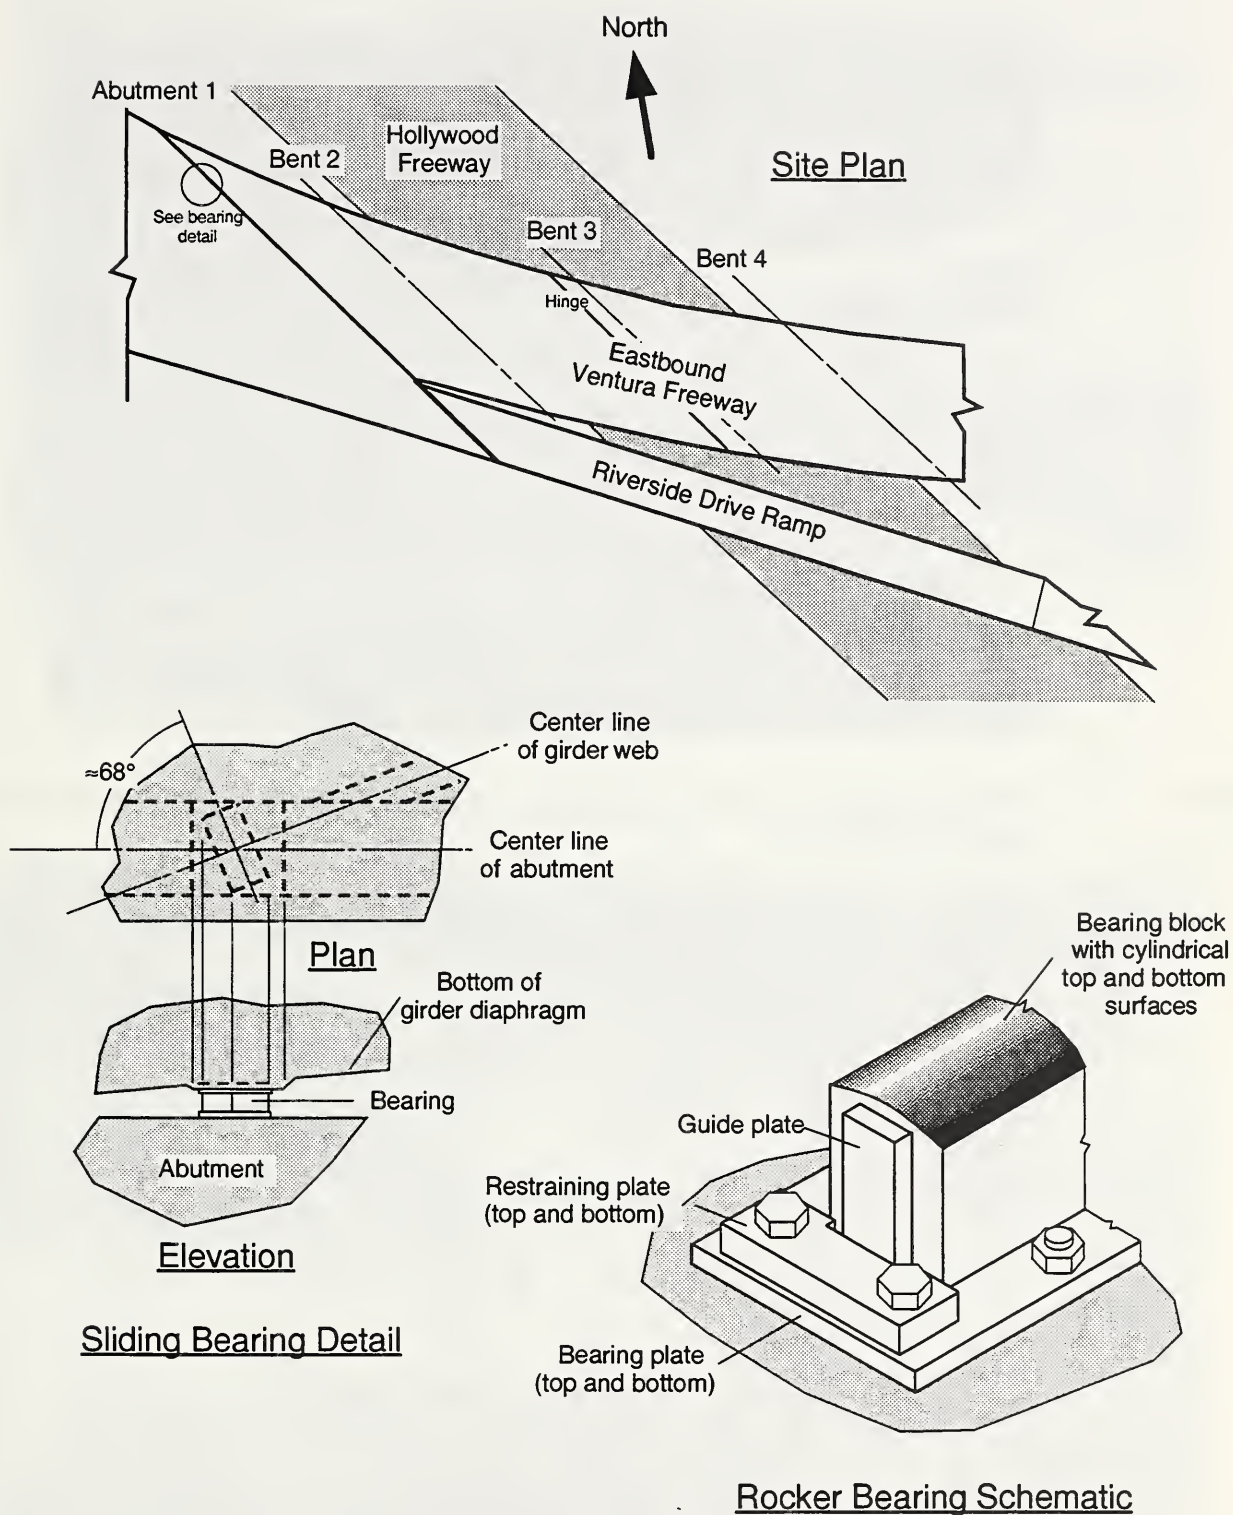
Figure 4.46 shows a simplified plan of the eastbound lane of the Ventura Freeway and the Riverside Drive ramp. Figure 4.47 is a ground level view of the eastbound lane as seen from the northbound lane of the Hollywood Freeway. At Abutment 1 (Figure 4.46), bearing supports are provided at the locations of the webs in the box girder. As shown in Fig. 4.46, the longitudinal axes of the bearings are aligned at right angles to the longitudinal axes of the girder webs. The four bearings on the north side of the eastbound lane of Ventura Freeway are of the sliding-type. Figure 4.48 shows the type of damage that was observed at these locations. Apparently, the dynamic frictional resistance of the bearing resulted in forces sufficient to spall off the shell of the abutment. The remainder of the bearings supporting the eastbound lane and the Riverside Drive ramp are of the rocker type. Figure 4.46 shows a schematic of this type of bearing. A steel bearing block with cylindrical surfaces is located between steel plates set into the abutment and girder end diaphragm. The blocks are kept in position with a system of guide plates and restraining plates as shown in Figure 4.46. All of the rocker bearings showed some type of earthquake damage. The bolts for the restraining plates were sheared off at many locations, and the sheared bolt heads were found at distances of up to several meters from their original position. Some of the bearing blocks were skewed from their original positions (Figure 4.49). In one case, the bearing block had tipped over resulting in a complete loss of support at that location (Figure 4.50).

Figure 4.46 Eastbound lane of Ventura Freeway crossing over Hollywood Freeway; site plan and bearing details

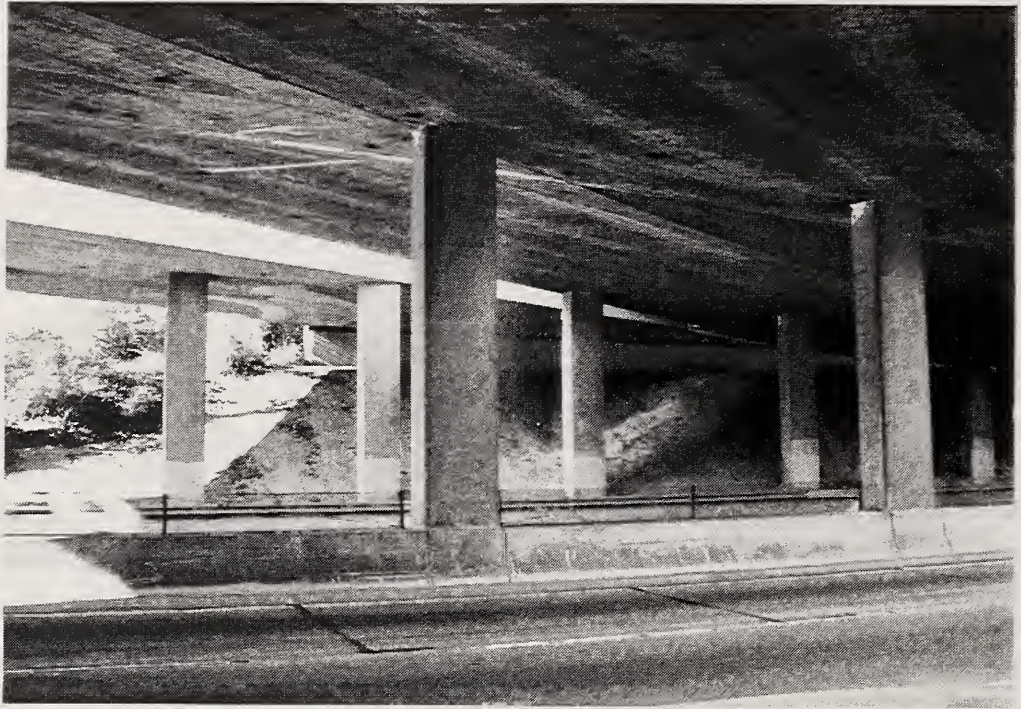
Figure 4.47 Eastbound lane of Ventura Freeway as seen from the northbound lane of Hollywood Freeway

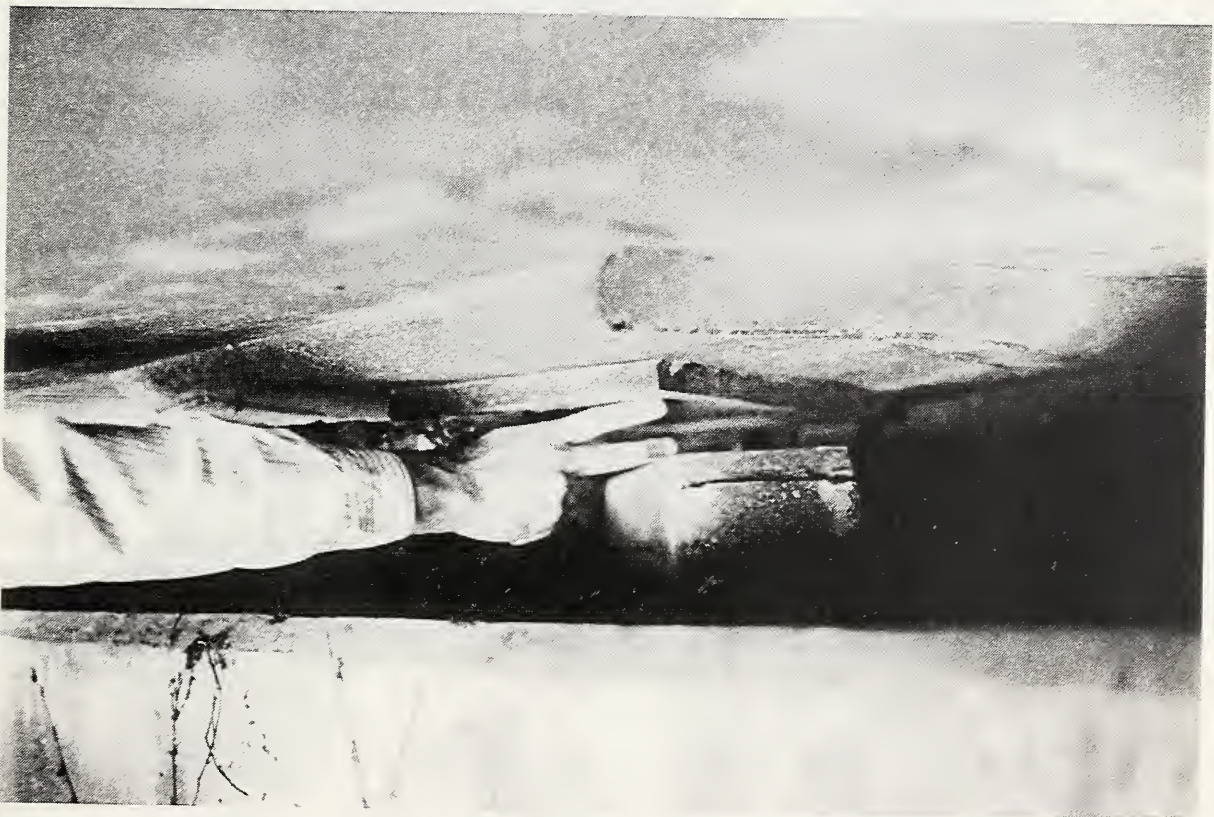
These observations highlight the unsuitability of rocker-type bearings to withstand the effects of seismic deformations. Because of redundancy, the failure of one bearing may not result in serious damage to the supported girder. However, multiple bearing failures could drastically alter the forces in the girder, and these forces could exceed the girder capacity.

Figure 4.50 Bearing block tipped over at this location resulting in loss of support to girder

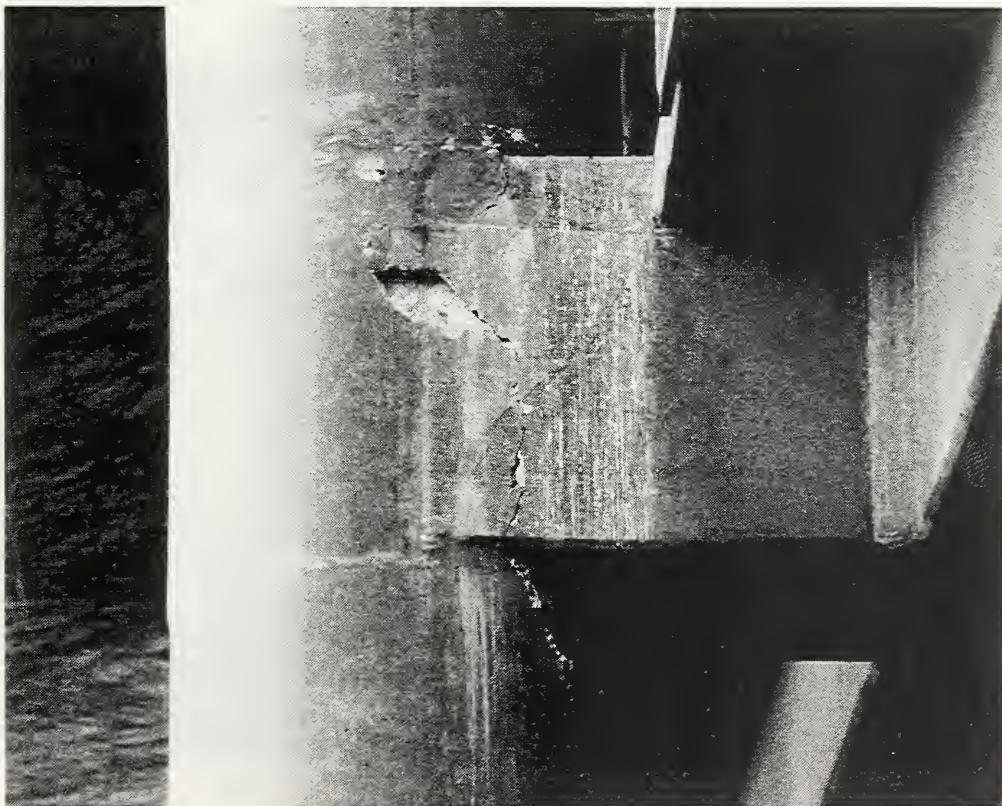
The damage observed in the Northridge earthquake possibly arose from three factors. First, the joint regions where cracking occurred are not as heavily reinforced as they would be under current design standards. Second, the structural hinges at the bases of most outrigger piers tended to increase the moments imposed on the outrigger joints. Third, the Jefferson Blvd. Undercrossing shares piers with the SR90 ramp above, as shown schematically in Figure 4.55. The upper SR90 structure is more flexible than the lower Jefferson Blvd. Undercrossing, possibly resulting in further concentrations of moments at the outrigger joints.

Figure 4.54 Close-up of the outrigger joint at the SR90/I405 interchange, Jefferson Boulevard Undercrossing, center bent, east side, looking to the south

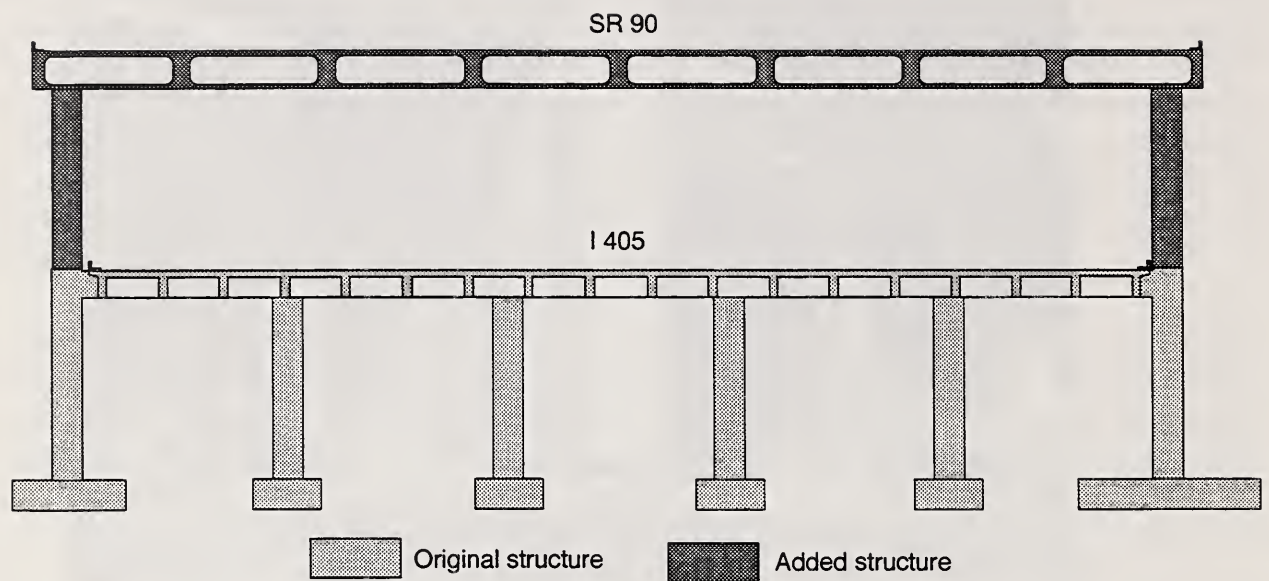
This bridge was constructed in about 1961, so generally speaking it does not meet current seismic design standards. The bridge is somewhat unusual because in the original design allowances were made for future construction of the ramps of the SR90/I405 interchange passing overhead: the outermost piers of the bridge were more heavily reinforced to allow for later extensions of the height of those piers. The reinforcement in the exterior piers consisted of 22 #18 bars (57 mm) longitudinally, and #5 bar (16 mm) spiral hoops spaced at 114 mm (4.5 inches); the inner piers were reinforced with 14 #9 bars (29 mm) longitudinally, and #4 (13 mm) spirals spaced at 305 mm (12 in.). The exterior piers were later extended in height, as can be seen in Figure 4.53. It is not clear how structural continuity was achieved between the original exterior piers and the pier extensions, since no explicit provisions were made in the original design for extending the longitudinal reinforcement.

Figure 4.55 Schematic cross section, showing columns shared by SR90 and the Jefferson Boulevard Undercrossing

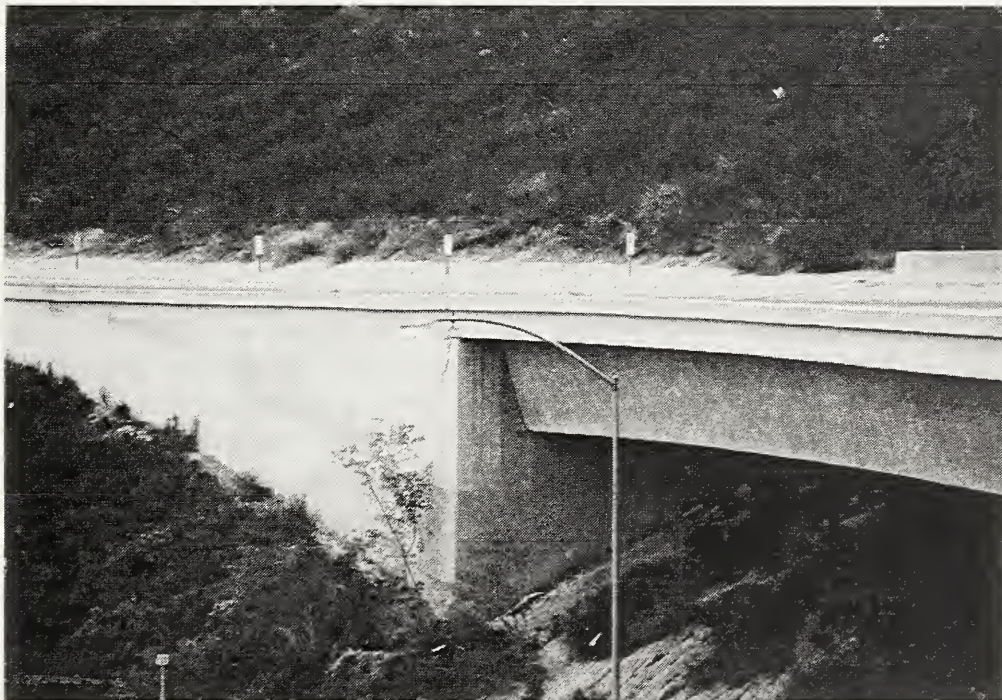
In the Northridge earthquake, bridge abutment damage ranged from minor settlement of backfill soil at the approaches, to cracking of wing walls, to permanent displacement of the entire abutment. For example, at the intersection of State Route 118 and Interstate 210, there was damage to the abutment at the east end of the long elevated structure connecting eastbound SR118 with northbound I210. An overview of the abutment is shown in Figure 4.56, and a close-up of some of the abutment sidewall cracking is shown in Figure 4.57. At the interchange of US101, SR134 and SR170, at the Riverside Drive Offramp Overcrossing (Caltrans bridge No. 53-1493S, described above) the abutments at both ends of the offramp exhibited severe cracking in the wing walls. Damage to concrete abutment piles was reported (EERC, 1994) at the Las Virgenes Overcrossing on US101 (Caltrans bridge No. 53-1442). There were many other cases of bridge abutment damage observed by the reconnaissance team, and reported by other investigators, which are too numerous to list here.

Figure 4.56 Overview of abutment at the east end of the ramp connecting eastbound SR118 with northbound I210

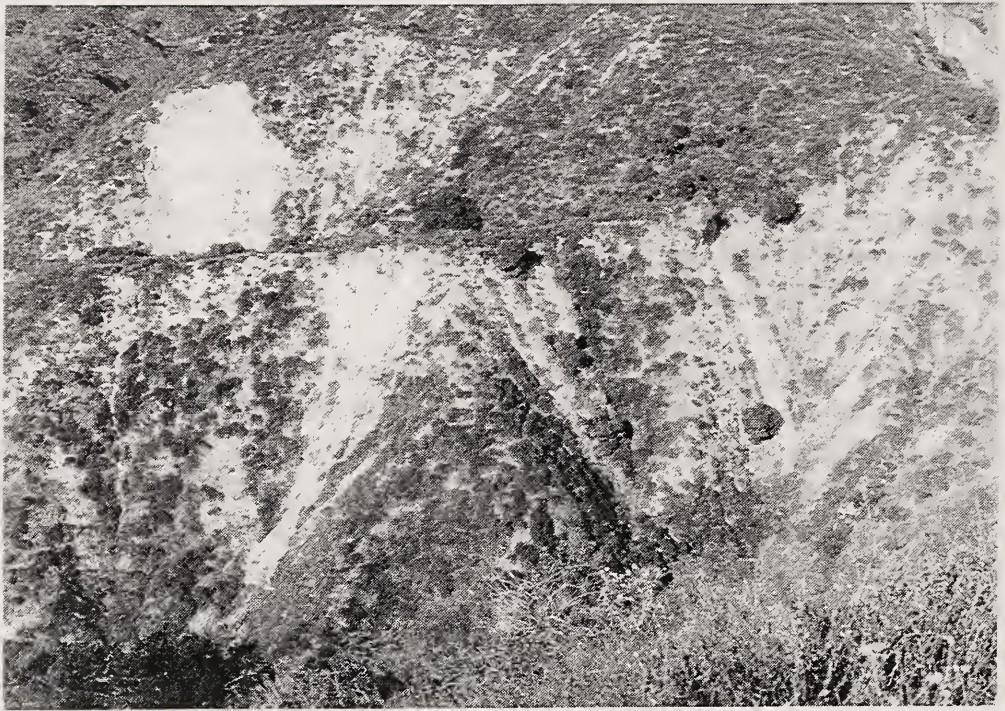
Among the numerous situations that contributed to the disruption of the water supply system was damage to one of the four damaged pipelines, Los Angeles Aqueduct No. 2 at Terminal Hill. Aqueduct No. 2 is made of 2.1-m (77 in.) diameter steel pipes. (Pipeline diameters range from 1.4 to 3 m (54 to 120 in.)) Terminal Hill is located about 20 km (12.5 miles) north-northwest of the epicenter, southwest of the intersection of I-5 and SR14. There is no strong motion record available for the site. However, two stations maintained by the California Division of Mines and Geology (CDMG) and the U.S. Geological Survey (USGS) about 5 km (3 miles) south of the site showed peak ground accelerations over 0.9g, indicating that the site probably was strongly shaken by the earthquake. Another indication of strong shaking can be seen from the numerous landslides along the mountainside to the north of the site (Figure 5.1).

Figure 5.1 Strong shaking at Aqueduct No. 2 at Terminal Hill can be inferred from the numerous landslides along the mountain slopes to the north of the site.

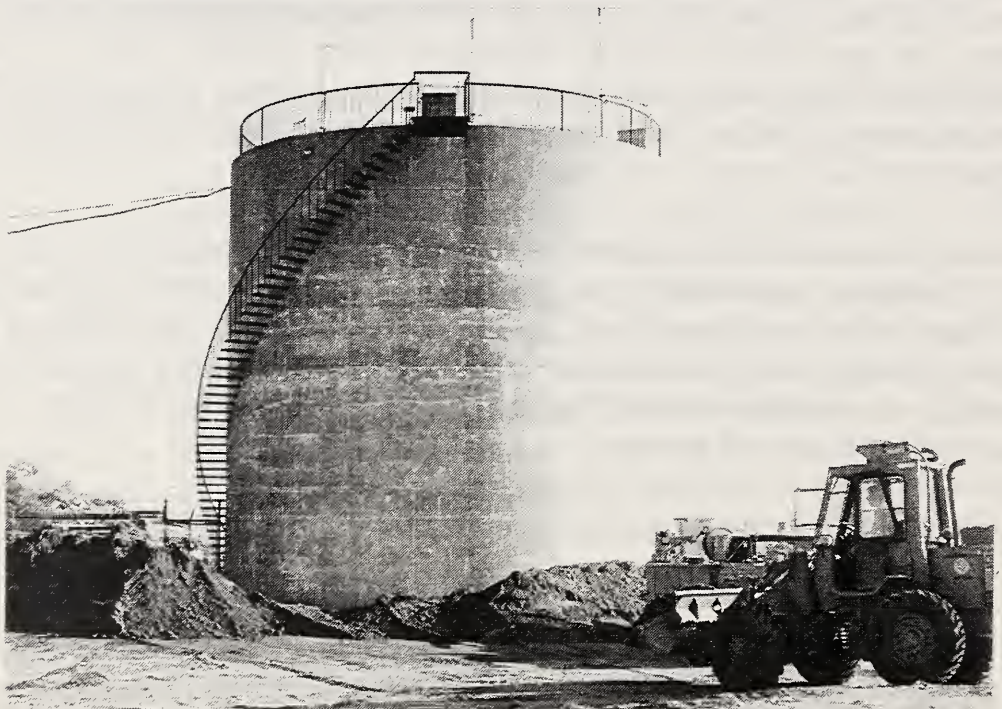
The reinforced concrete relief tank (surge chamber) on top of the hill appeared to perform well through the earthquake--no damage was observed (Figure 5.2). A steel pipe brings water up from the canyon below (Figure 5.3). The pipe is supported on concrete saddles built along the mountain slope. In a few places, the pipe separated from the saddles creating 50 to 80 mm (2 to 3 in.) gaps. In at least one location, the pipe crashed into the saddle. In two other locations, the pipe sections bulged 80 mm and 150 mm (3 and 6 in.) respectively. However, no rupture or leakage was noticed. The ruptured section of the 2.1-m pipe is located near top of the hill. The two sections where the rupture occurred were connected together using a mechanical coupling system (Figure 5.4). To restrain the relative movement between the two pipe sections during strong shaking, the sections were connected by eight pairs of restrainer rods 35 mm (1-3/8 in.) in diameter and 2.2 m (7 ft) long. The rods were attached to brackets, which were welded to the pipes. These welds broke due to strong shaking (Figure 5.5) and resulted in the separation of the two pipe sections.

Figure 5.2 The reinforced concrete surge tank at Terminal Hill performed well during the earthquake--no damage was observed.

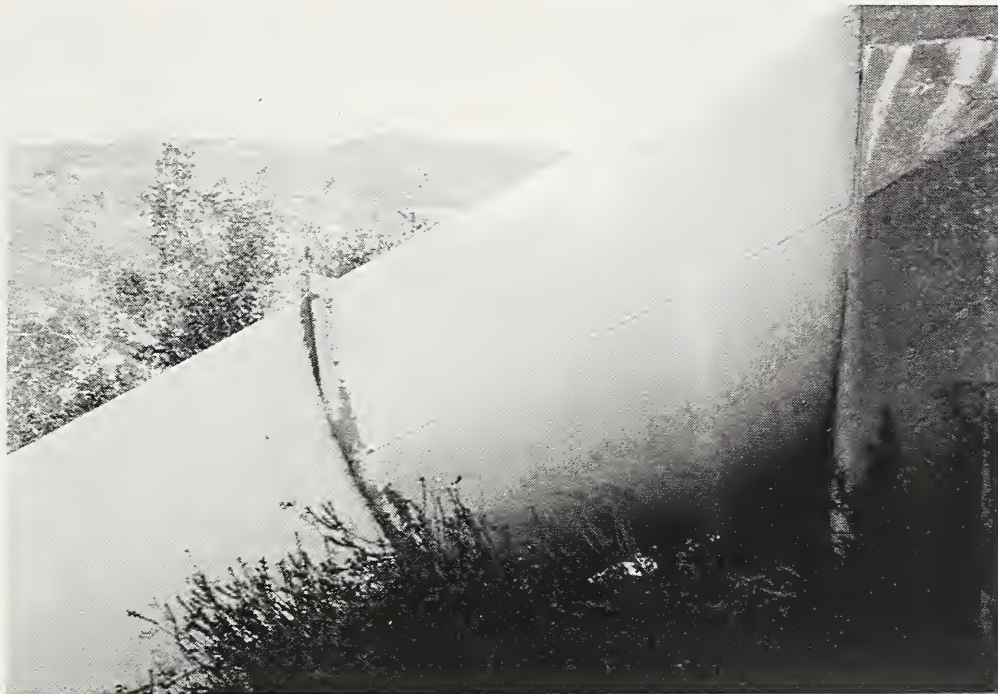
Figure 5.3 The steel pipeline at Terminal Hill separated from its supporting saddle at several places and pipe sections bulged at other locations along the alignment.

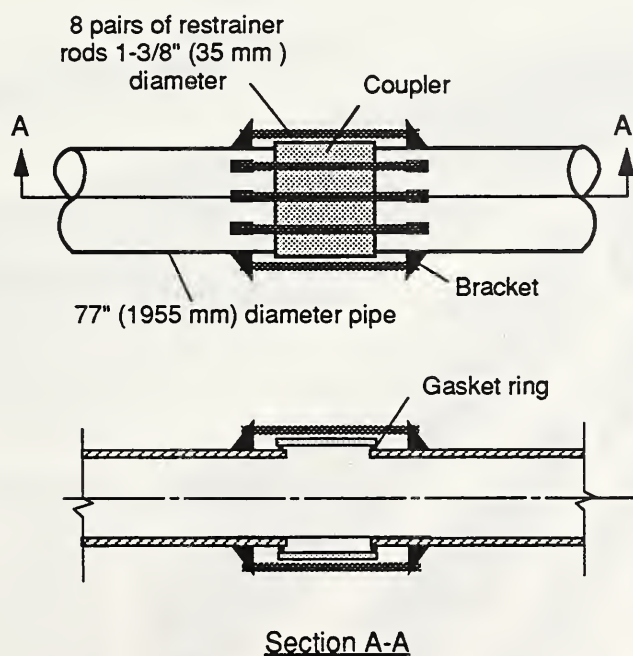
Figure 5.4 Schematic drawing of connection of the two steel pipe sections which were pulled apart during the earthquake.

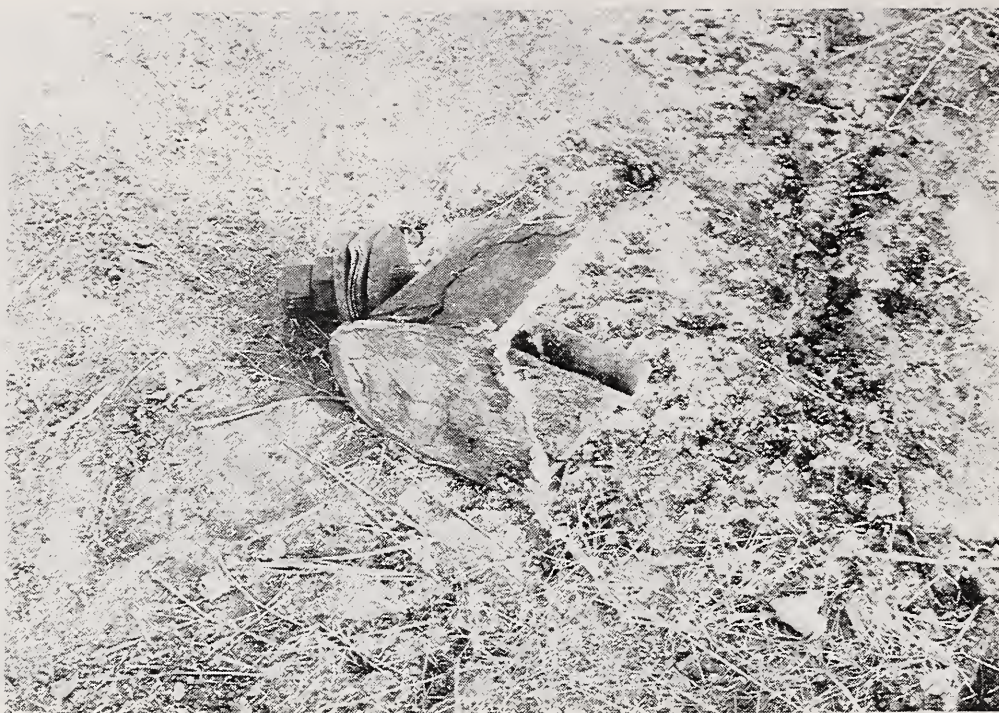
Figure 5.5 Welds of the restrainers broke as the result of strong shaking.

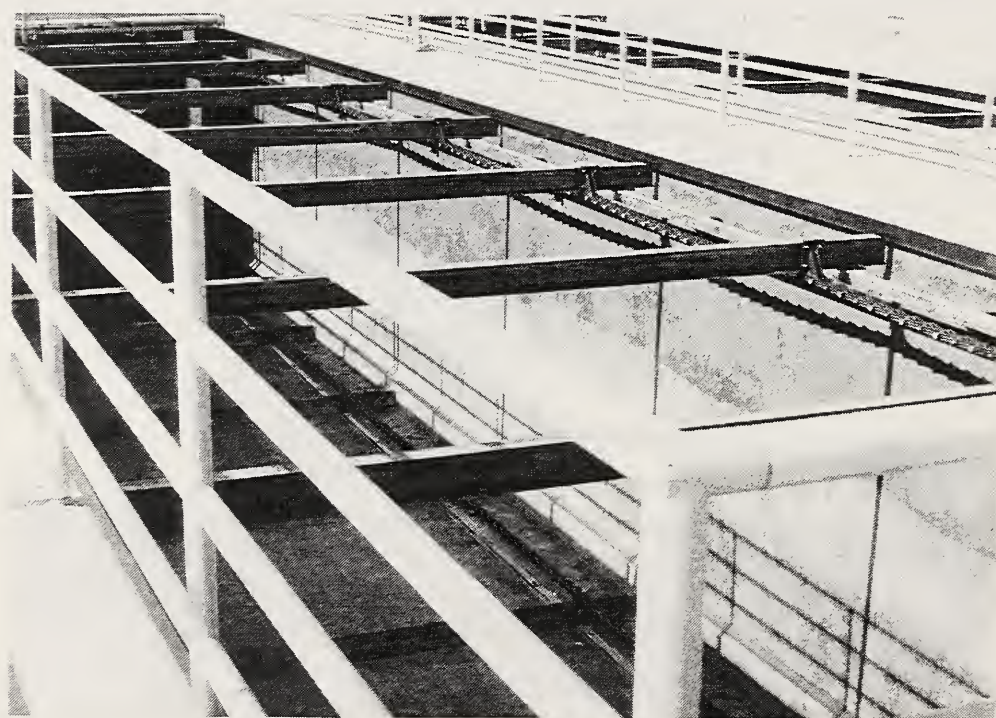
The earthquake resulted in damage to five out of twenty-two final clarifier tanks built in 1991 as the Phase II expansion. Twenty-two Phase I tanks built in 1983 survived the earthquake without damage. Figure 5.6 shows a typical undamaged final clarifier tank. The scrapers are supported by railings attached to the walls with brackets. Chains are used to move the scrapers. All these components were made of plastics in the Phase II construction, whereas the brackets were made of metal and railings and scrapers were made of redwood in Phase I. Pins about 10 mm (3/8 in.) in diameter and 19 mm (3/4 in.) long connected the brackets to the railings. In the tanks where the system failed, it is suspected that the pins dislodged as the result of wave action in the tank and displaced the railing, therefore jamming the movement of the chain, which disabled the system (Figure 5.7).

Figure 5.6 Undamaged clarifier tank at the Tillman Water Reclamation Plant.

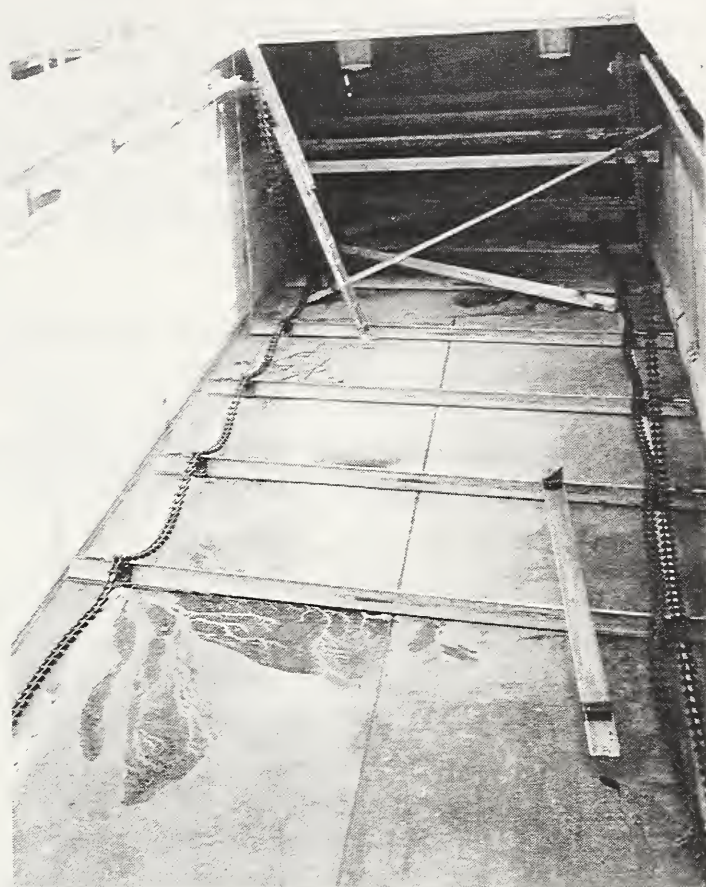
Figure 5.7 A damaged sludge scraper in a clarifier tank at the Tillman Water Reclamation Plant.

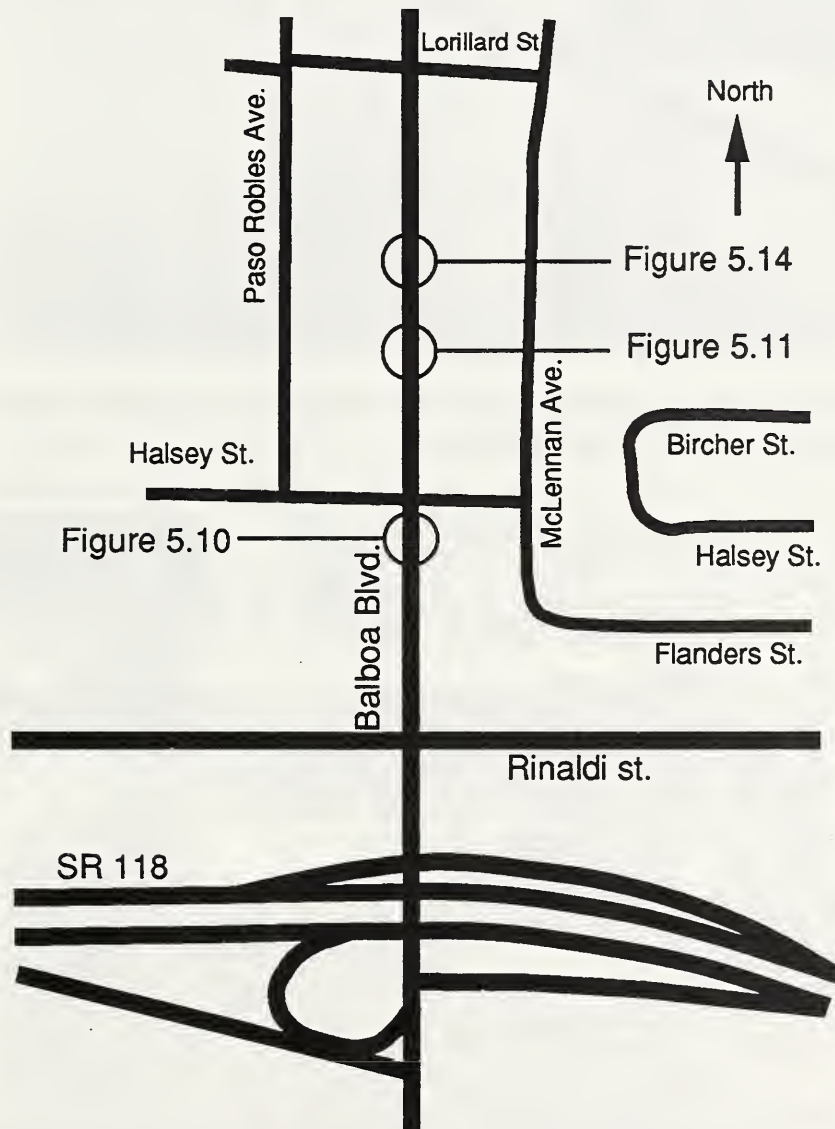
The rupture of a 0.6-m (22-in.) gas main occurred along Balboa Boulevard between Rinaldi Street to the south and Lorillard Street to the north, about 0.5 km (0.3 miles) north of the intersection of Balboa Boulevard and SR118 (Figure 5.8). Along this stretch, compressional ground failures occurred between Rinaldi Street and Halsey Street, and extensional ground failures occurred between Bircher Street and Halsey Street. Ground extension at this location is prominently exhibited by the transverse cracks in the pavement as shown in Figure 5.9. Further, lateral spreading of 25 to 100 mm (1 to 4 in.) toward the west was observed along the sidewalk on the west side of Balboa Boulevard north of Halsey Street, whereas no lateral spreading was observed on the east side of Balboa Boulevard.

Figure 5.8 Location of the 0.6-m gas main rupture on Balboa Boulevard.

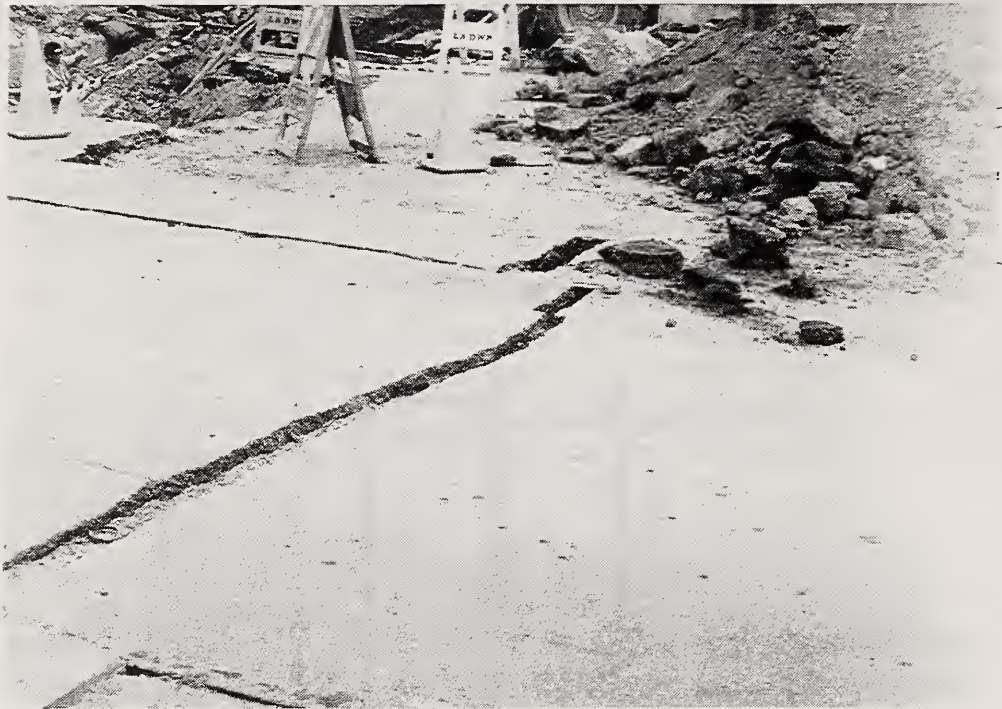
Figure 5.9 Ground extension at the gas fire site on Balboa Boulevard can be seen by the transverse cracks in the pavement.

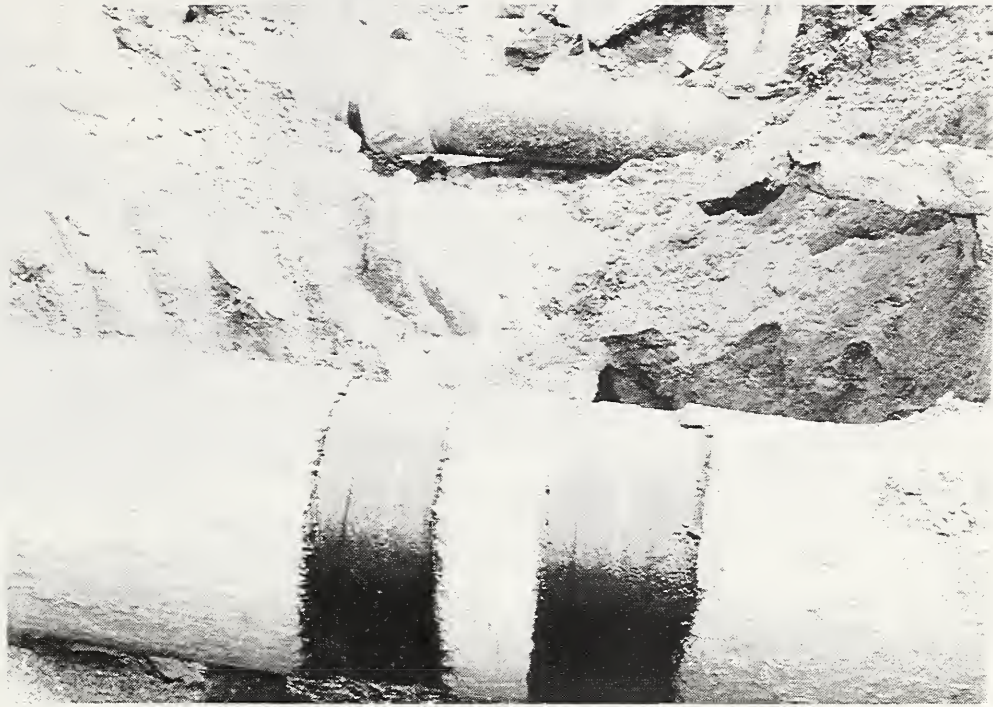
About one block north, the ground extension caused rupture of the same 0.6-m (22-in.) gas main and a 1.2-m (48-in.) water main (Figure 5.11). These pipes were pulled apart as the result of the ground extension. The rupture of the gas main caused a major fire at the site that destroyed five houses (Figures 5.12 and 5.13). The loss of both water mains at this location and the difficult access to the site due to the fire and flooding in the street made fire fighting difficult.

Figure 5.11 Ground extension along Balboa Boulevard resulted in the rupture of the same gas main and water main shown in Figure 5.10. The rupture of the gas main here caused a major fire that engulfed five houses.

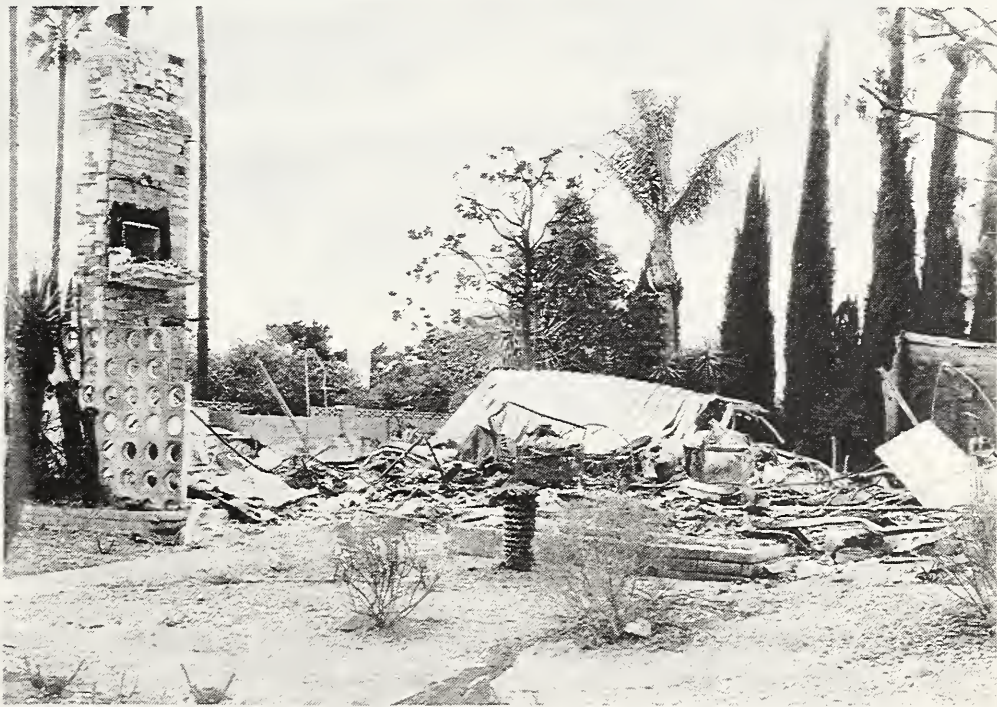
Figure 5.12 Houses destroyed by a fire resulting from the rupture of the 0.6-m gas main along Balboa Boulevard.

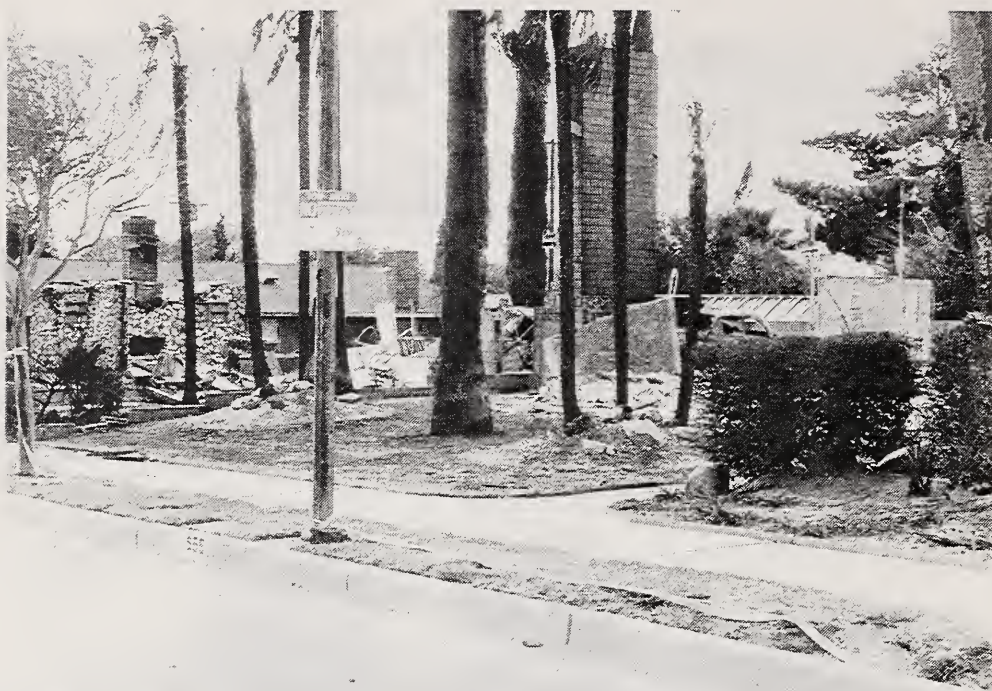
Figure 5.13 Houses destroyed by a fire resulting from the rupture of the 0.6-m gas main along Balboa Boulevard.

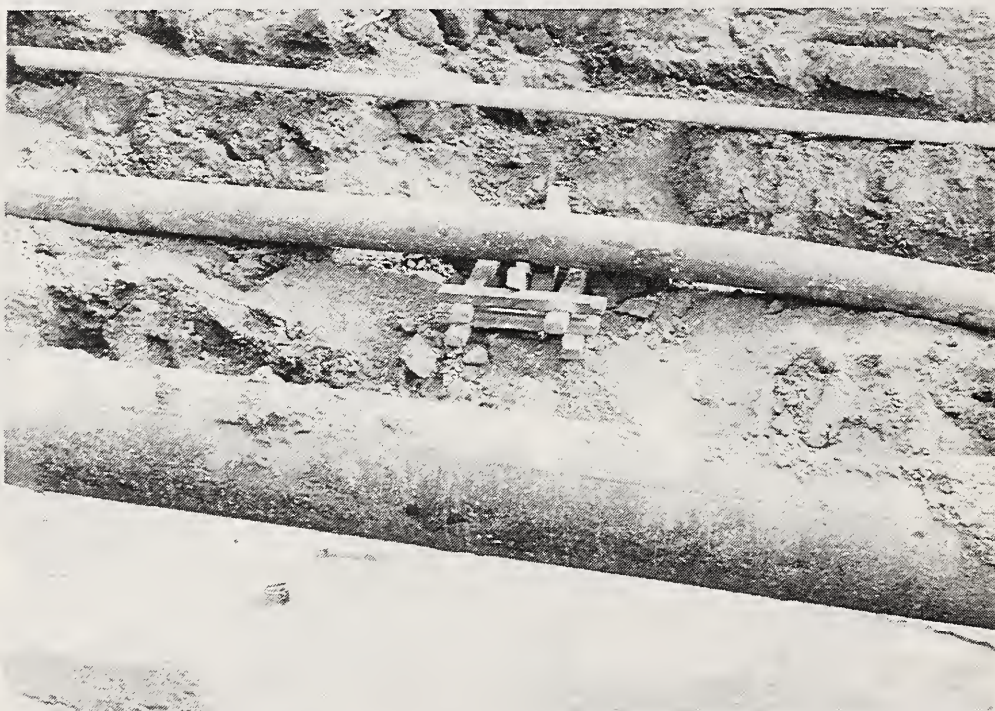
Figure 5.14 Some of the buried pipelines located near the intersection of Balboa Boulevard and Bircher Street--the potential hazard of co-location of lifeline systems. At this site are three water lines (two of them main lines); three gas lines; two sewers; one crude oil line; overhead power, telephone, and cable TV lines; the street lighting system; and the street itself.

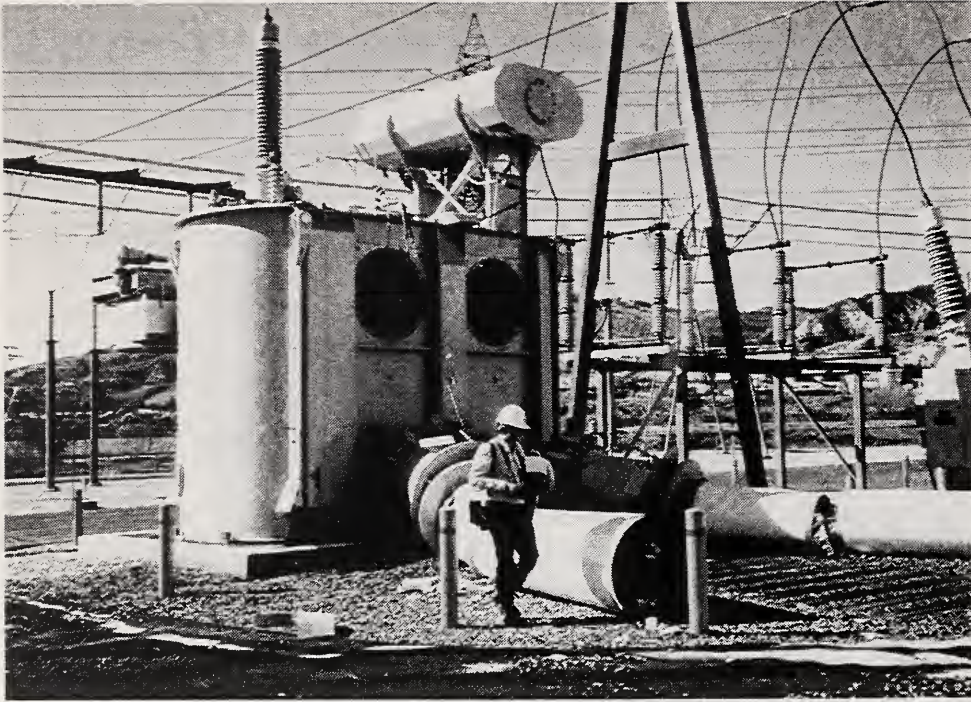
Figure 5.15 Damage to DC equipment at several high voltage substations, such as this one at Sylmar, led to widespread power outages in the Los Angeles area as well as isolated outages throughout seven western states. (Photo courtesy of Edward Matsuda, Pacific Gas and Electric Company.)

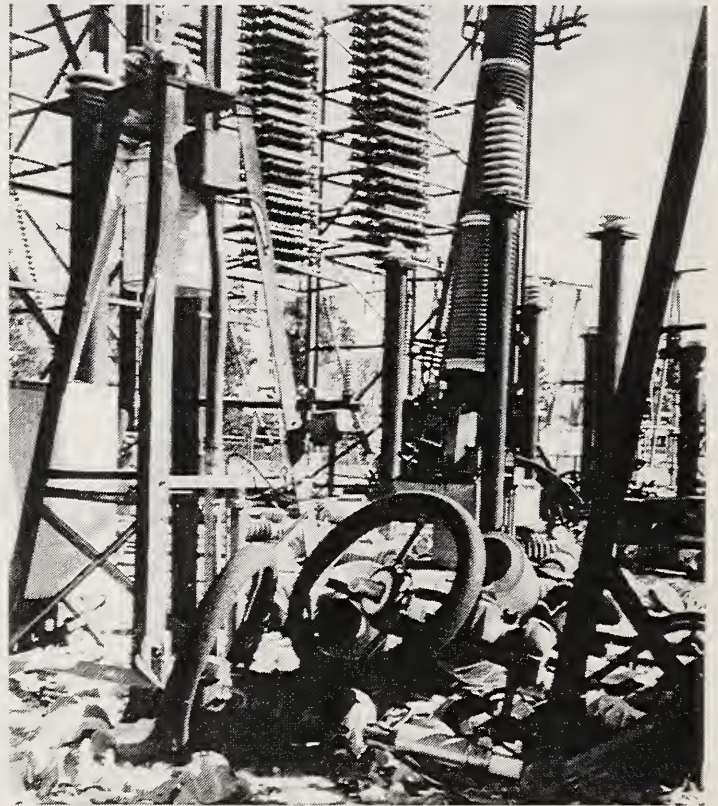
Figure 5.16 Porcelain is an integral part of high voltage electrical equipment due to insulation requirements and is also the most vulnerable to damage during strong earthquake shaking. (Photo courtesy of Edward Matsuda, Pacific Gas and Electric Company.)

- Improved methods for avoiding damage to high voltage substations should be supported. New materials should be developed to replace the brittle porcelain insulators. Better switch systems should be developed and installed to prevent blackouts in areas serviced by the system. Failures of foundations for transmission towers should be more thoroughly investigated.

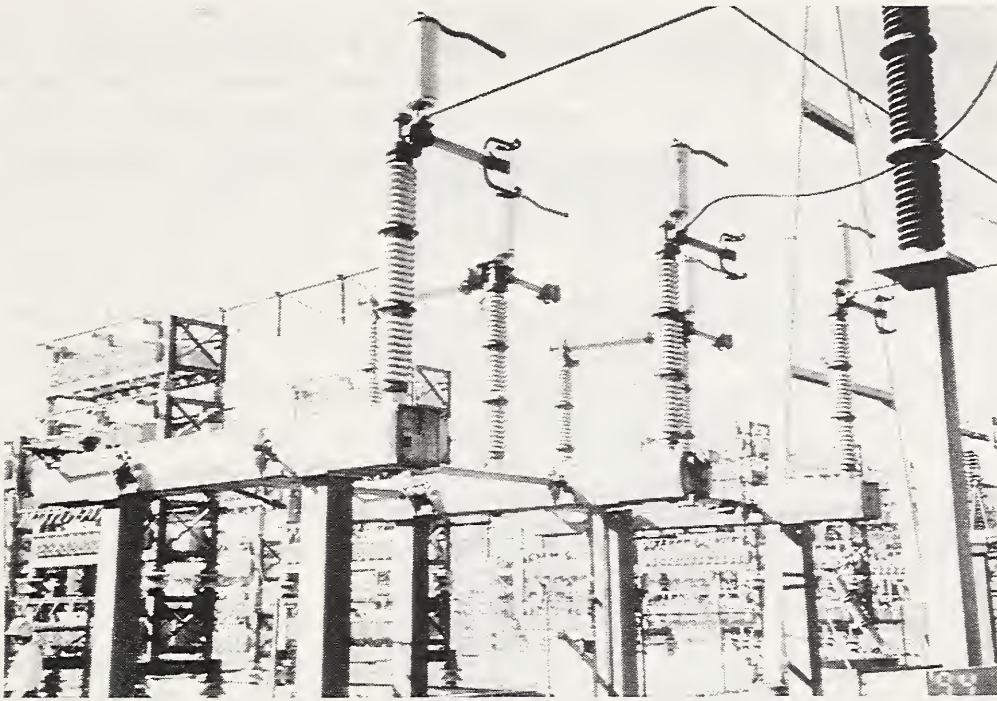
Figure 5.17 Most of the 230 kV circuit switchers (in the forefront) at the Sylmar substation were damaged. Most of the capacitor banks (in the background) performed well in this earthquake, whereas most collapsed during the 1971 quake. (Photo courtesy to Edward Matsuda of Pacific Gas and Electric Company.)

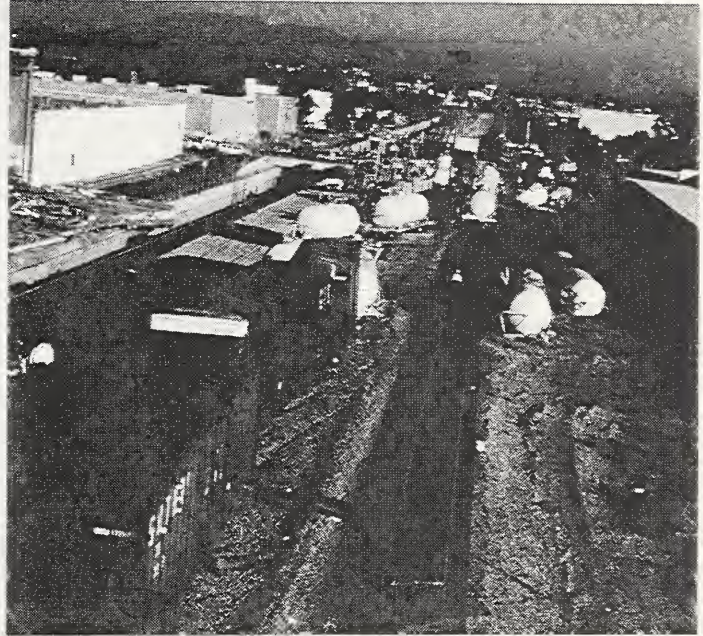
There was a freight train derailment in Northridge during the earthquake (Figure 5.18). The 64-car freight train belonged to Southern Pacific and was on its way from Houston to Sacramento. Twenty-five cars derailed, sixteen of which carried sulfuric acid or diesel fuel. The derailment resulted in the spill of 30,000 liters (8,000 gallons) of sulfuric acid and 7,500 liters (2,000 gallons) of diesel fuel. There were no casualties in this incident. About 200 m (650 ft) of railroad tracks were replaced immediately following the earthquake and rail service was restored at 2:00 a.m., January 19. Removal of damaged cars and cleanup of debris were completed on January 21.

Figure 5.18 Derailment of a 64-car freight train in Northridge. The incident resulted in the spill of 30,000 liters of sulfuric acid and 7,500 liters of diesel fuel.

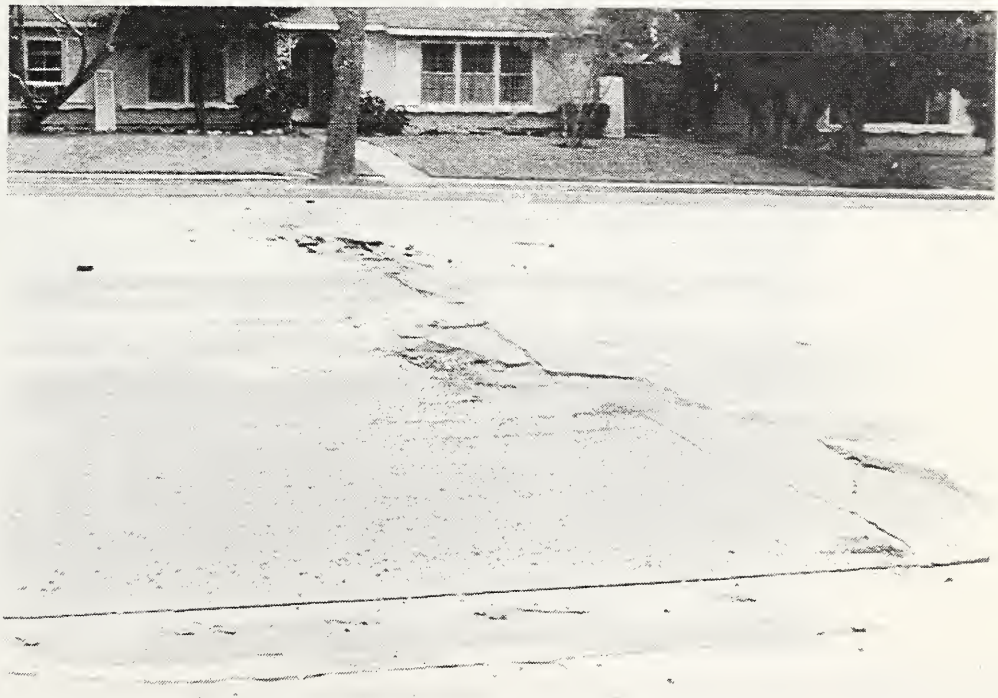
Strong ground shaking and lateral movement of subgrade materials resulted in numerous ruptures of asphalt pavement and concrete sidewalks in the epicentral area (Figures 5.19 and 5.20). In some instances, local traffic was interrupted temporarily waiting for the repair of these cracks. In most cases, the damage was minor and local traffic was not interrupted. The south approach of Balboa Boulevard at SR118 caved in because of loss of abutment fill due to a water main break (Figure 5.21). This bridge was closed for traffic due to some structural damage to the piers and the loss of the south abutment fill.

Figure 5.19
Transverse cracks
in pavement along
Balboa Boulevard
in Northridge area.
